**Zimmer®
Prolong®
Highly
Crosslinked
Polyethylene**

Improved polyethylene performance

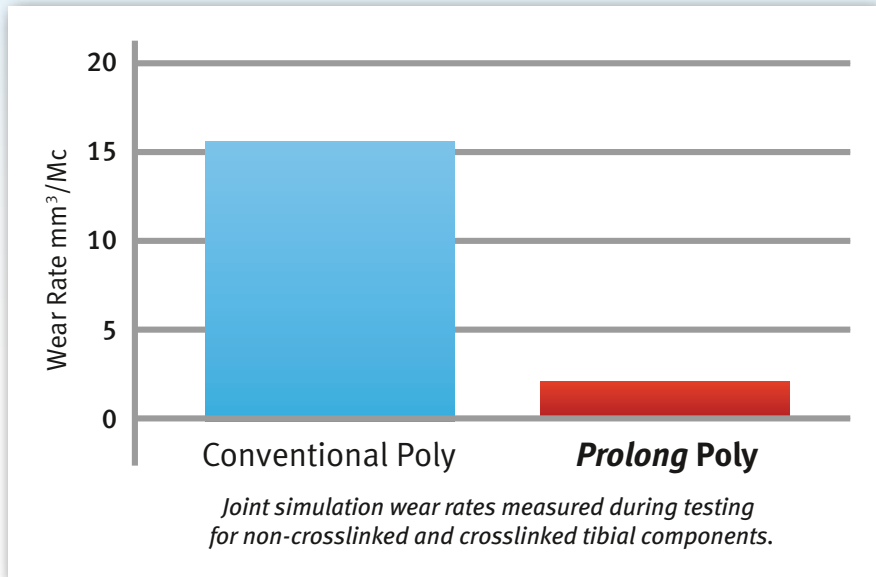
WEAR RATES

In laboratory testing, conventional polyethylene components exhibited almost 8x more wear than the Prolong polyethylene samples.

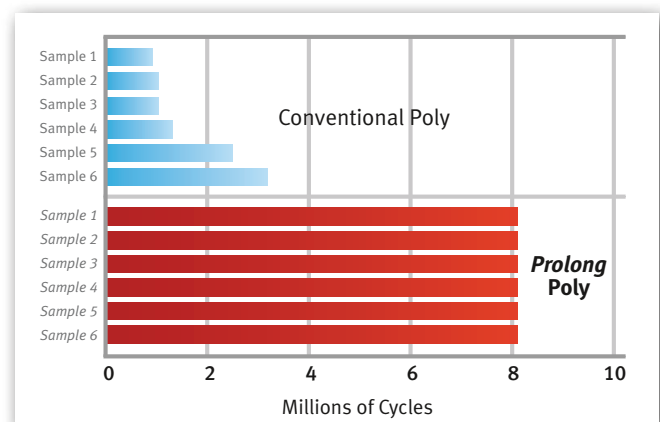
START OF DELAMINATION IN LABORATORY TEST SAMPLES

Conventional Test Sample

Prolong Polyethylene Test Sample

In head-to-head testing specifically designed to result in early onset of delamination, conventional polyethylene inserts repeatedly showed signs of delamination, as compared to Prolong polyethylene, which showed no evidence of delamination.

A recent study compared highly crosslinked polyethylene with conventional polyethylene in an accelerated delamination test. After two million cycles, no evidence of delamination or pitting was shown in the highly crosslinked samples, while half of the conventional samples showed evidence of pitting.¹⁰

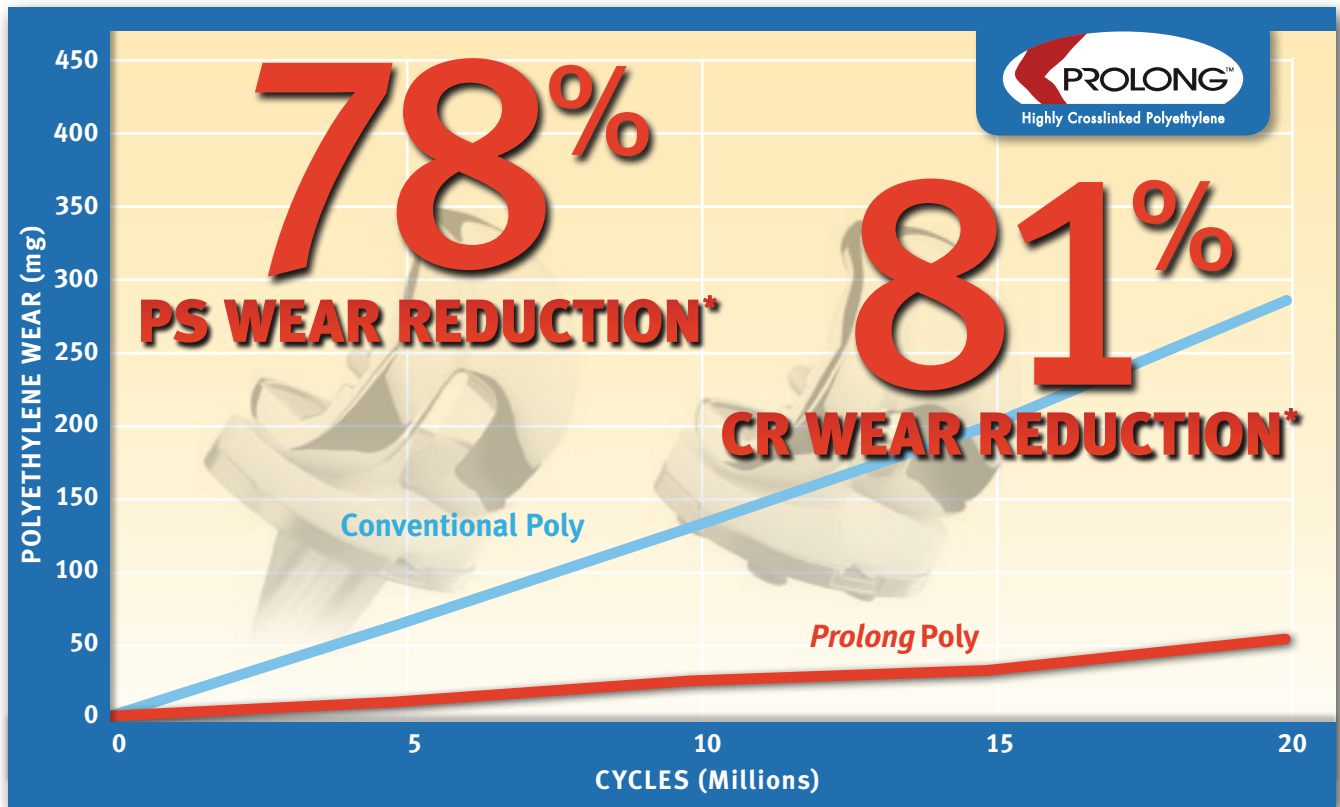
**In vitro wear simulator testing demonstrated an 81% reduction in total volumetric wear of CR articular surface components and a 78% reduction in total volumetric wear in PS articular surface components compared to conventional polyethylene. The results of in vitro wear tests have not been shown to correlate with clinical wear mechanisms.*
